Refurbishment of Bergen's Decorative Art Museum 'KODE 1' by 3RW arkitekter

Location: **Bergen, Norway**

Architect: **3RW arkitekter**

Status: **Built, 2017**

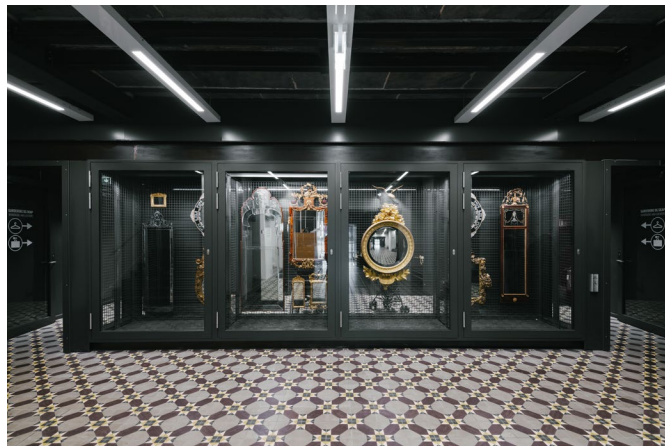
New entrance hall mirror display from the museum's archives; copyright 3RW arkitekter

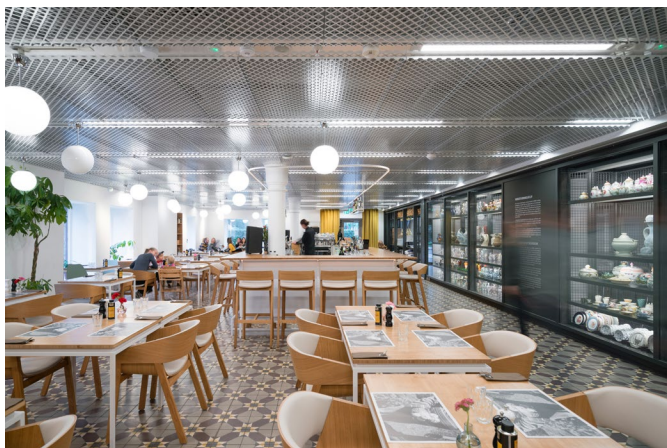
The new restaurant on ground floor, Bien Centro, with the museum archive exhibition wall; copyright 3RW arkitekter

This unfolding wall contributes differently to the spaces it creates throughout the museum: as an exhibition wall and as a filter between the publicly accessible spaces of the museum - the cafe/restaurant, shop, children's room, conference room and library space - and the working spaces of the museum, for the first time exposed to the public.

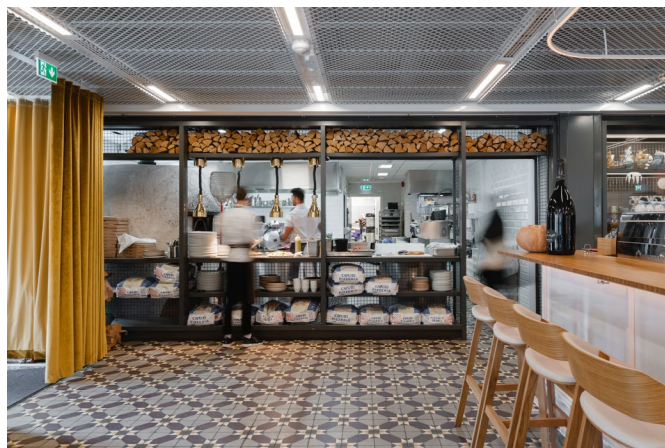
The restaurant's kitchen is articulated as a continuation of the exhibition display wall; copyright 3RW arkitekter

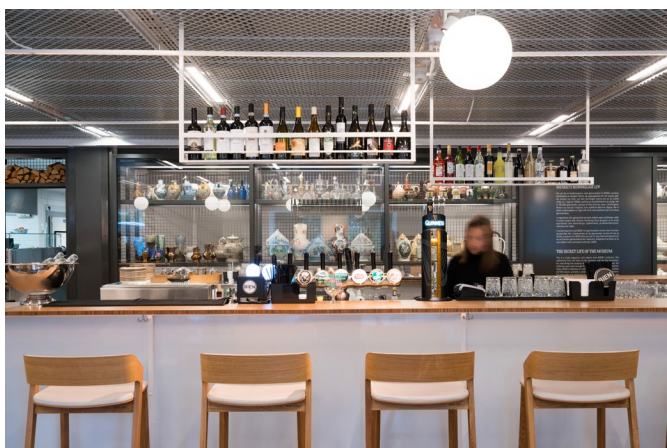
Bar at the centre of the new restaurant with the museum archive wall as backdrop; copyright 3RW arkitekter

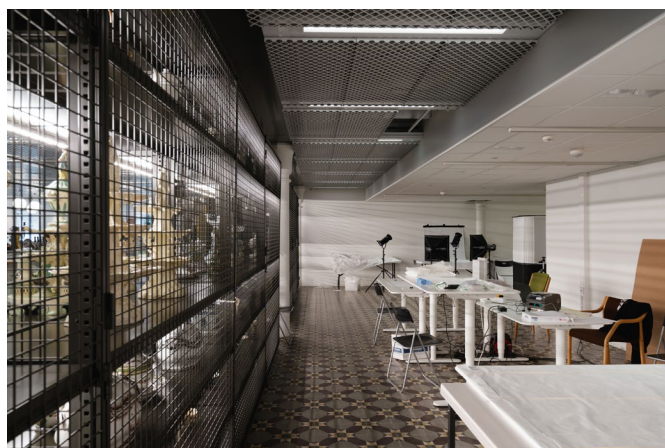
Conservation spaces separated from the restaurant by the display wall; copyright 3RW arkitekter

To achieve visual connectivity between the archives and back-of-house activities of the museum, and the public areas, the wall has security levels that are made possible by a succession a layers.

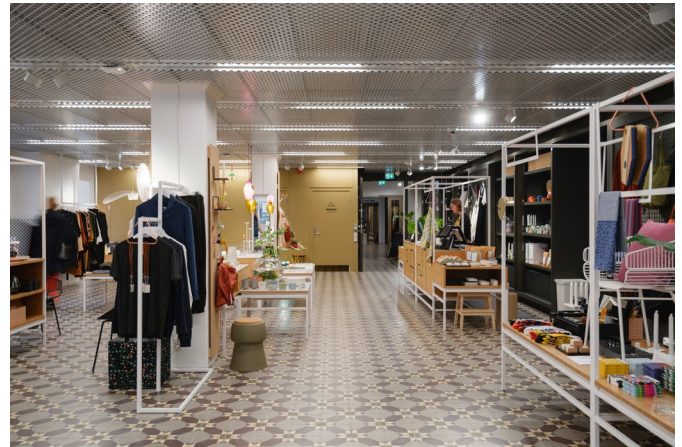
The new museum shop contains Norwegian design items; copyright 3RW arkitekter

New modular furniture was created to form the new reception desks, restaurant and event tables, bar, and series of shop displays. These were inspired from old Norwegian museum displays with slender steel units and flexible arrangements. A white steel mesh ceiling and custom-made carpets and curtains complete a list of key interior elements that were added to the museum to give it a new civic presence.

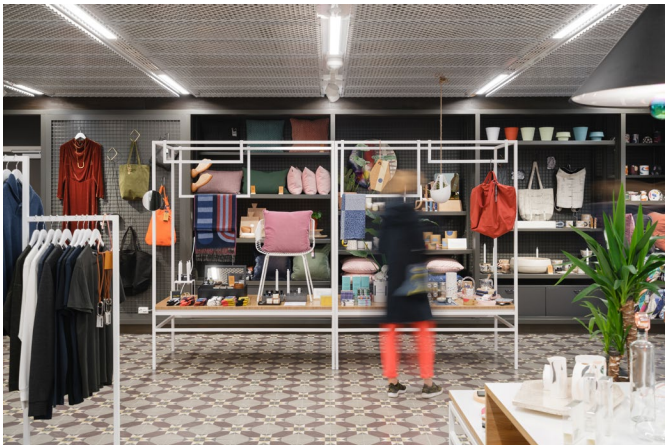
Shop items are displayed on a new modular furniture inspired by ancient Norwegian display units; copyright 3RW arkitekter

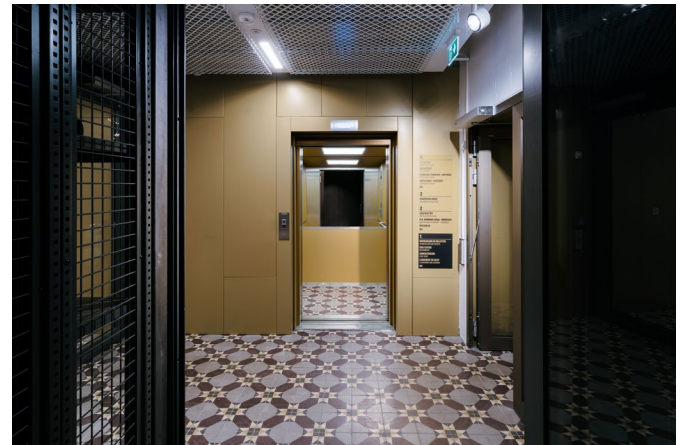
A golden core containing vertical circulation follows all floors of the museum; copyright 3RW arkitekter

The main elements are supported by warmer additions: a wooden floor; a series of custom-made carpets and curtains featuring old plans and photos of the museum; and a golden element accentuating the public access from ground floor to the top floor.

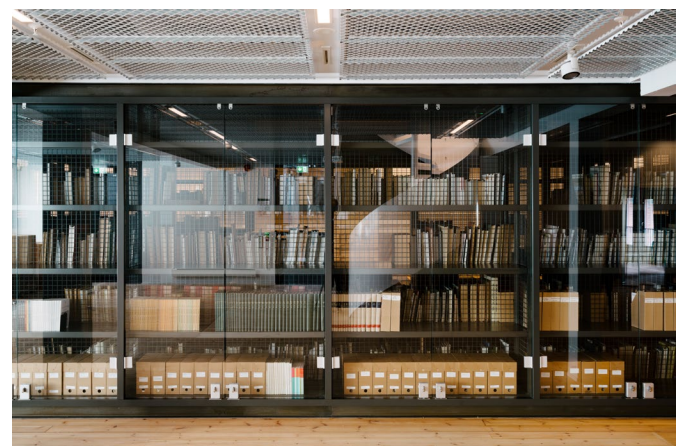
Display wall detail in the library space; copyright 3RW arkitekter

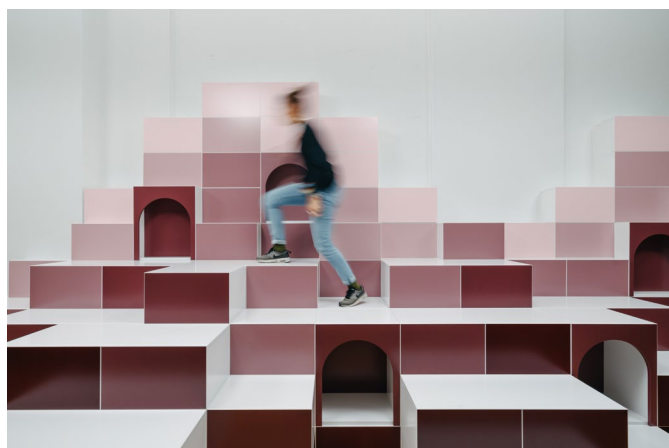
New children's play room with custom-designed cascading furniture; copyright 3RW arkitekter

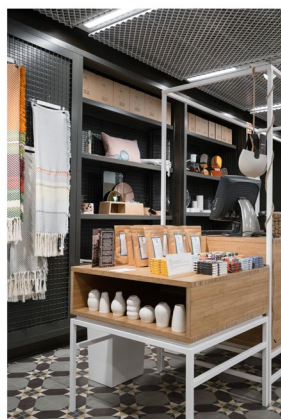
MAIN DESIGN ELEMENTS

Main interior elements; copyright 3RW arkitekter

The character of the interior is defined by three main elements: the internal display wall of natural dark oiled steel; colourful cement tiles with an ancient pattern found during the demolition process; and a custom-made, white metal mesh ceiling. All these elements are based on a 1600 mm grid that runs throughout the project. This set becomes the new language driving KODE 1's rehabilitation.

The tiles and the ceiling are designed as a dialogue between the traditional geometry and its abstracted interpretation.
